DEVELOPMENT OF A DESIGN TECHNOLOGY FOR GROUND SUPPORT FOR TUNNELS IN SOIL

Volume III: Observed Behavior of an
Earth Pressure Balance Shield in
San Francisco Bay Mud

G. Wayne Clough
Richard J. Finno
Bryan P. Sweeney
Edward Kavazanjian

February 1983
Final Report

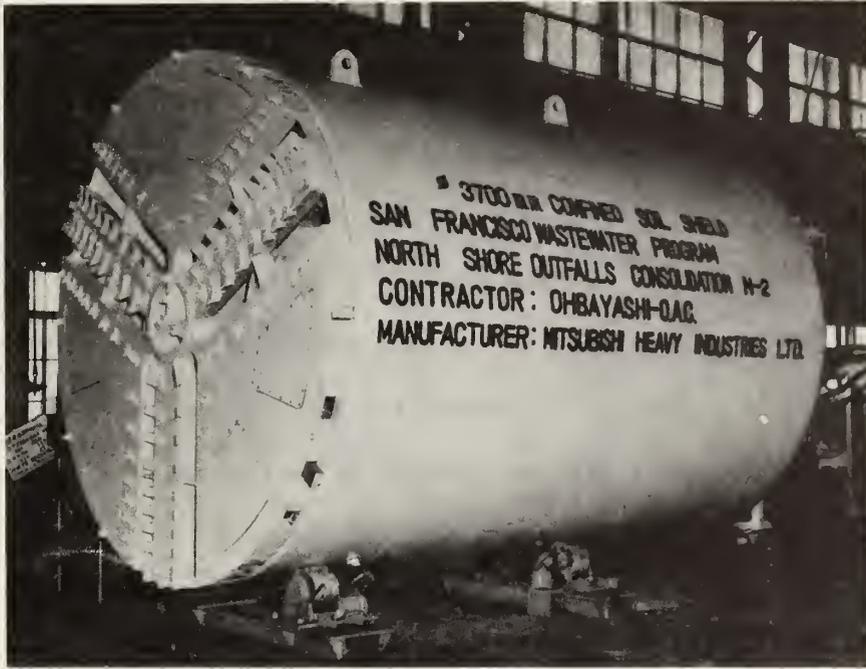
Figure 3.1: Front View of Earth Pressure Balance Shield

Front and rear view photographs of the EPB shield for the N-2 project, as assembled at the Mitsubishi manufacturing plant in Japan are shown in Figure 3.1 and 3.2. The front view shows the "blind" rotating cutterhead at the leading end of the shield. There are three sets of two slots in the cutterhead face which allow the excavated soil to enter into the shield. Between each set of slots are two rows of cutter teeth, pointed in opposite directions, which excavate the soil as the head is rotated. Only one set of teeth are in use during a given direction of rotation. The paired rows of teeth are set in opposite directions to allow the shield head to be rotated in either a clockwise

The front view of the shield also shows two other features of the EPB cutterhead. First, between the slots and teeth there are bolted trapezoidal shaped plates set flush into the face. These can be opened in case of emergency to remove blockages or replace cutter teeth. Second, along the periphery of the cutterhead there are several small openings with recessed solid steel bars, termed overcutters, which can be extended several inches into the surrounding soil. One such bar can be seen extended in the lower portion of the cutterhead in Figure 3.1. These are used only in the event of a slight widening of the tunnel opening is needed to aid in steering the shield. They were never needed during the course of the N-2 project.

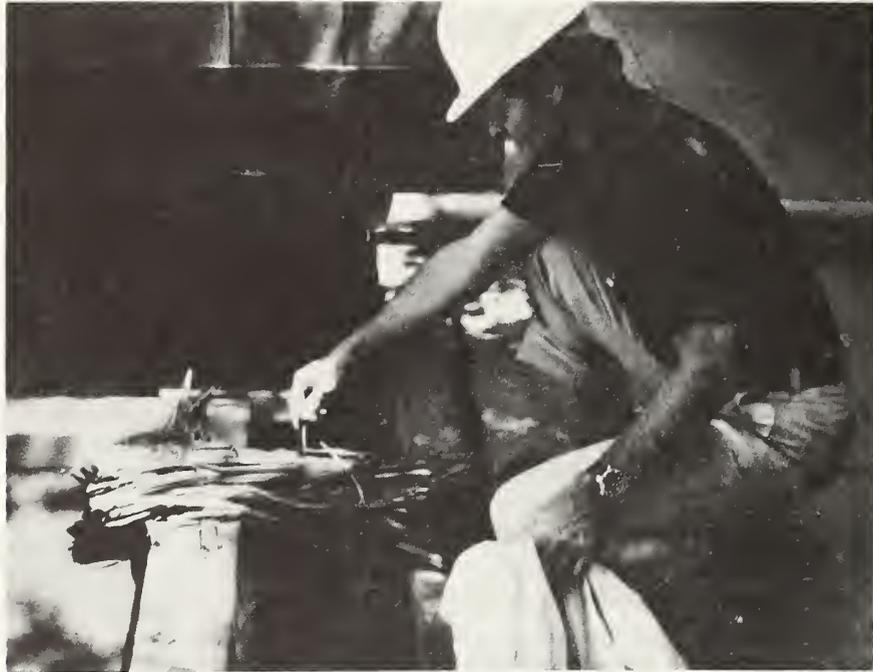
Figure 3.5: Remnants of Wooden Pile Excavated Through EPB Shield

The wooden piles along the alignment were readily cut to pieces by the carbide teeth on the cutterhead face. The contractor estimated that 90 piles were encountered. A photograph of a piece of pile after it passed through the shield is provided in Figure 3.5. This is one of the

larger chunks to emerge; many smaller pieces were found in the muck cars. The piles had three effects on the operations:
